# NEEDS DONE

RESIDENTIAL HOME INSPECTION REPORT

(MOCK)123 Main St., Hermitage, PA

FINAL REPORT

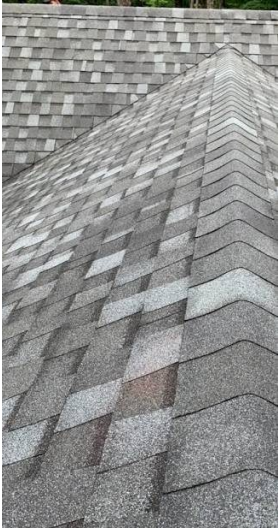
Roof-covering material — inspection view

✓ No concerns noted

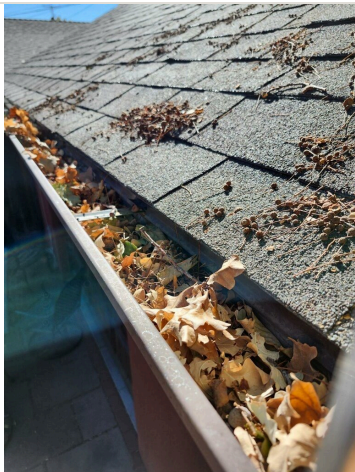
R-01 Routine Repair

Backside gutters.

Debris accumulation

The gutter had debris accumulation, primarily leaves.

The condition can allow water entry or accelerated weathering and may damage concealed materials if it progresses.

Debris accumulation — inspection view

Regularly clean gutters to ensure proper water flow/roof drainage.

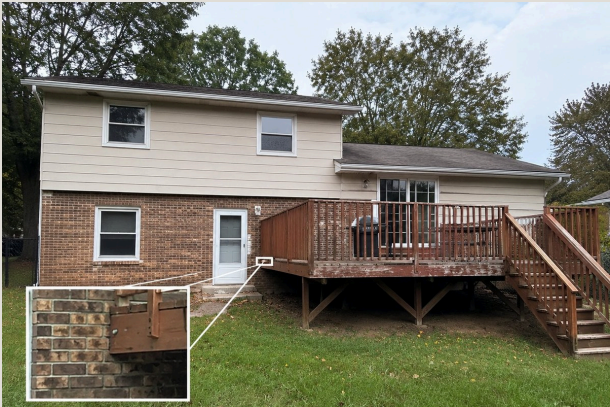
M-01Material Defect

Rear elevated deck at house connection

Deck is not properly attached to the house

Technical finding: Ledger attached to veneer or overhang

The rear deck ledger appears attached through brick veneer instead of directly to structural framing.

Brick veneer is not intended to support deck loads. An inadequate connection can allow the deck to separate or collapse.

Rear deck connection at brick veneer

Limit deck use and have a qualified deck contractor or structural professional evaluate and correct the connection.

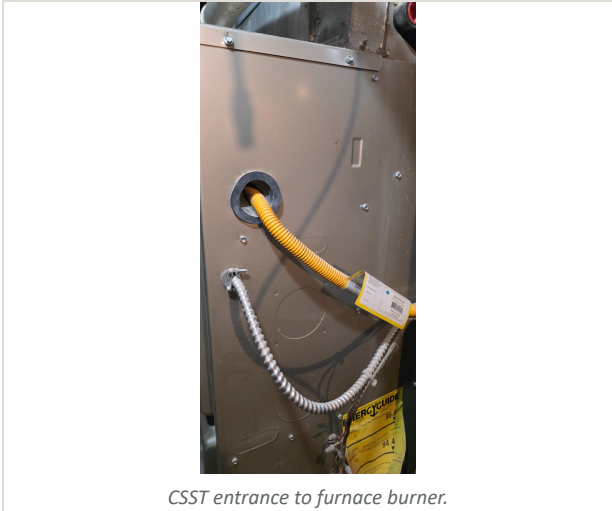
S-01 Safety / Significant

CSST bonding should be verified

Ungrounded CSST entering furnace.

Technical finding: CSST gas piping enters furnace cabinet without adequate protection

Corrugated stainless steel tubing (CSST) was observed. Proper bonding or grounding of the CSST system could not be confirmed at the accessible areas.

Nearby lightning can induce voltage on CSST. Without required bonding, arcing to nearby metal can perforate the tubing, release gas, and create fire or explosion risk.

CSST entrance to furnace burner.

Have a licensed electrician or qualified gas professional familiar with CSST verify bonding and grounding against the CSST manufacturer’s current instructions and correct the system if needed.

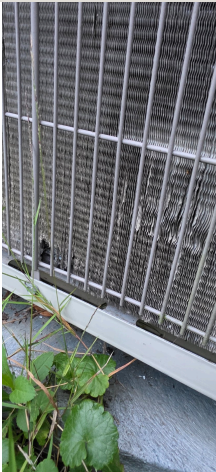
C-01

Visible damage

Localized condensor coil fin damage

Visible damage to the aluminum fins on the outdoor AC condensor unit.

The condition can reduce comfort, efficiency, or reliability and may lead to equipment damage.

Visible damage — inspection view

Have a qualified HVAC technician repair or replace the affected cooling system and verify the condition is corrected.

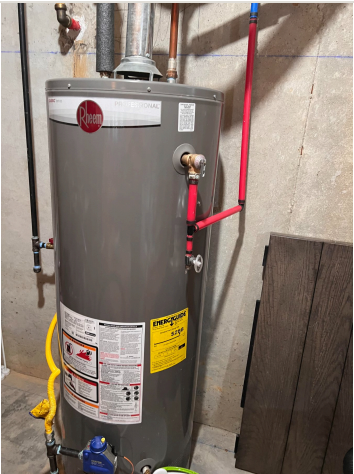
S-02 Safety / Significant

Basement natural-gas water heater

Water-heater safety discharge piping is improper

Technical finding: TPR valve or discharge concern

The water-heater temperature-and-pressure relief discharge pipe terminates too high above the floor.

Improper discharge piping can direct scalding water into an unsafe location and may not provide a safe relief path.

Water-heater safety discharge piping is improper — inspection view

Have a qualified plumber correct the TPR discharge piping to a safe, unobstructed termination.

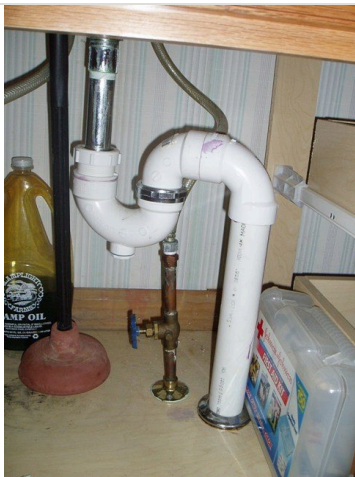
R-02 Routine Repair

Basement utility sink

Sink drain has an improper trap

Technical finding: S-trap, double trap, or improper trap visible

The sink drain uses an improper trap configuration at the noted location.

An improper trap can siphon dry or allow sewer gases to enter the home.

Sink drain has an improper trap — inspection view

Have a qualified plumber correct the drain to a properly vented, serviceable trap arrangement.

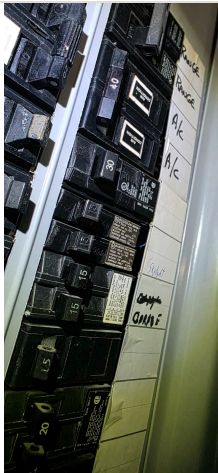
M-02 Material Defect

Improper breaker fit visible

30A breaker on right side of main panel.

The electrical panel had improper breaker fit, causing bowing and gaps in the dead front.

The condition can increase the risk of shock, overheating, arcing, or fire.

Improper breaker fit visible — inspection view

Have a licensed electrician correct the condition and verify the affected circuit or equipment is safe.

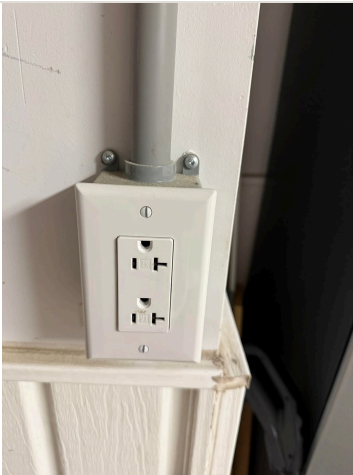
R-03 Routine Repair

Missing GFCI outlets in garage

Shock protection is missing at these outlets

Technical finding: GFCI absent where recommended

GFCI shock protection was not present in garages throughout garage.

GFCI protection reduces the risk of electric shock, especially in damp or wet locations.

Shock protection is missing at these outlets — inspection view

Have a licensed electrician add proper GFCI protection at the garage breaker or outlets.

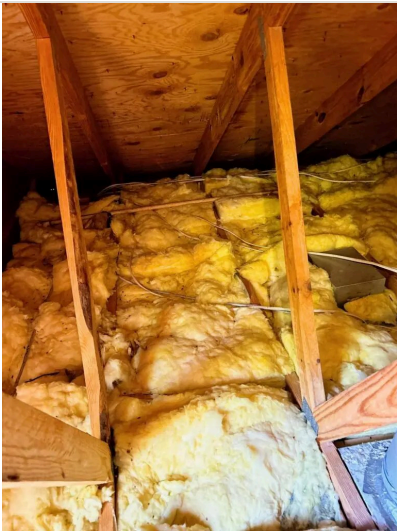
Insulation type observed — inspection view

| Insulation type observed | Fiberglass batt |
| Approximate average attic insulation depth | Approximately 8-10 inches in accessible areas |

| <div>✓ No concerns noted</div> <div>Insulation in unfinished spaces</div> | <div>Ventilation of unfinished spaces</div> <div>Soffit and roof-exhaust ventilation pathways were visible in accessible areas.</div> |

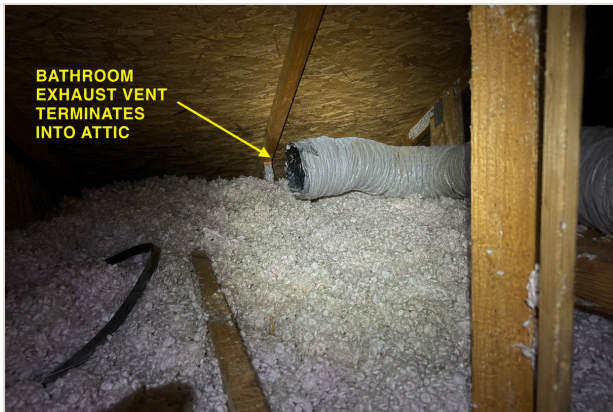
S-03 **Safety / Significant**

**Bathroom exhaust vents into the attic**

Main hall bathroom exhaust duct

*Technical finding: Discharges into attic*

The bathroom exhaust duct terminates in the attic instead of outdoors.

Moist exhaust air can contribute to condensation, roof-deck deterioration, and microbial growth.

*Bathroom exhaust duct terminating in the attic*

Have a qualified contractor route the duct to a proper exterior termination.

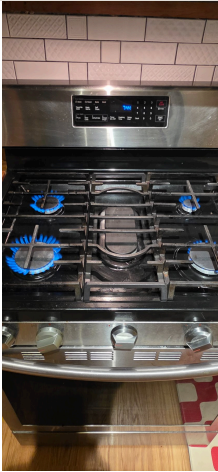
The center hot plate did not ignite. The bottom right burner was observed lower than expected at max setting.

Kitchen range burners did not all operate as designed.

The condition can affect normal operation and reducing cooking efficiency.

Abnormal flame pattern visible — inspection view

Have a qualified technician repair the range.
